**Subject: Annual Inspection Report
Floralia Municipal Airport**

ANNUAL INSPECTION REPORT

FLORALA MUNICIPAL AIRPORT

FLORALA, ALABAMA

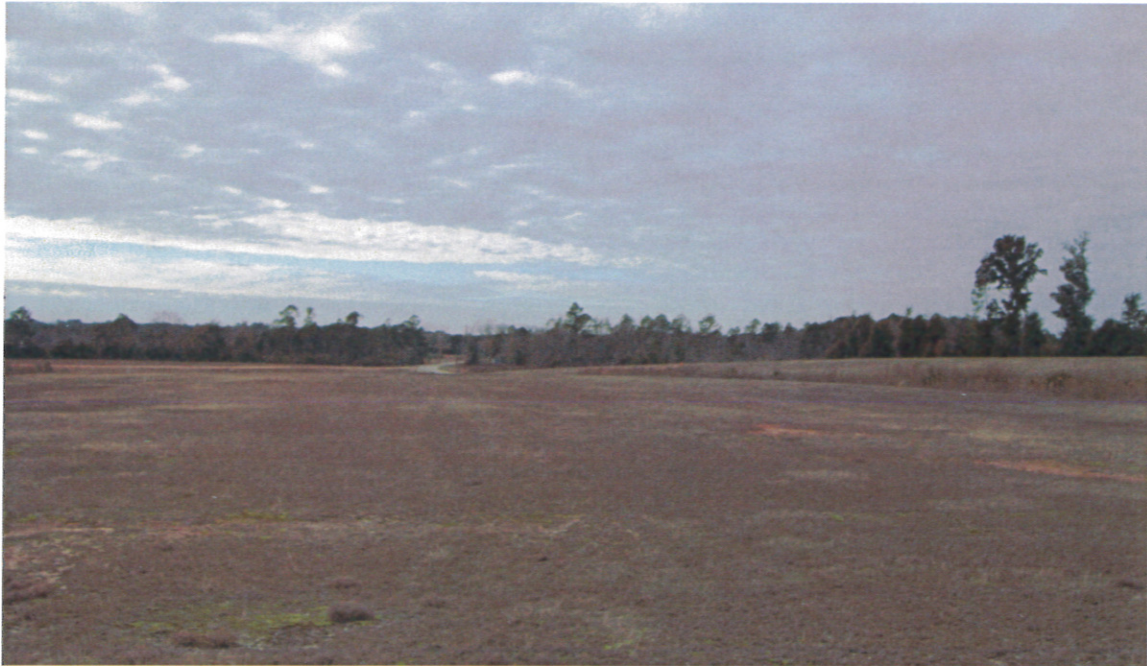
Photo # 1 –Runway 4

- Runway 4: No obstructions (Photo # 1)
- Runway 22: No obstructions (Photo # 2)

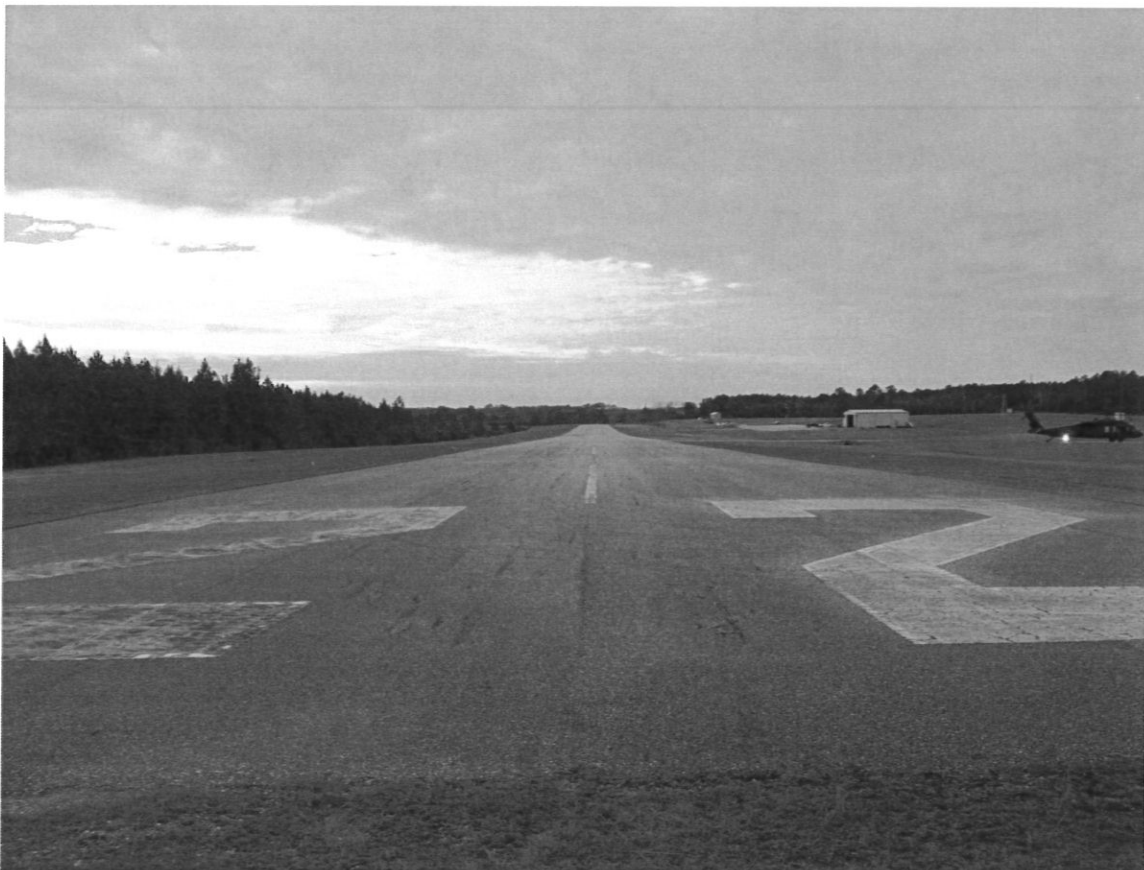
Photo # 3 – Runway Number & Centerline

- The markings for all runways are in fair condition due to fading (Photo # 3).

- Markings will soon need to be replaced in accordance with FAA AC 150/5340-1K.

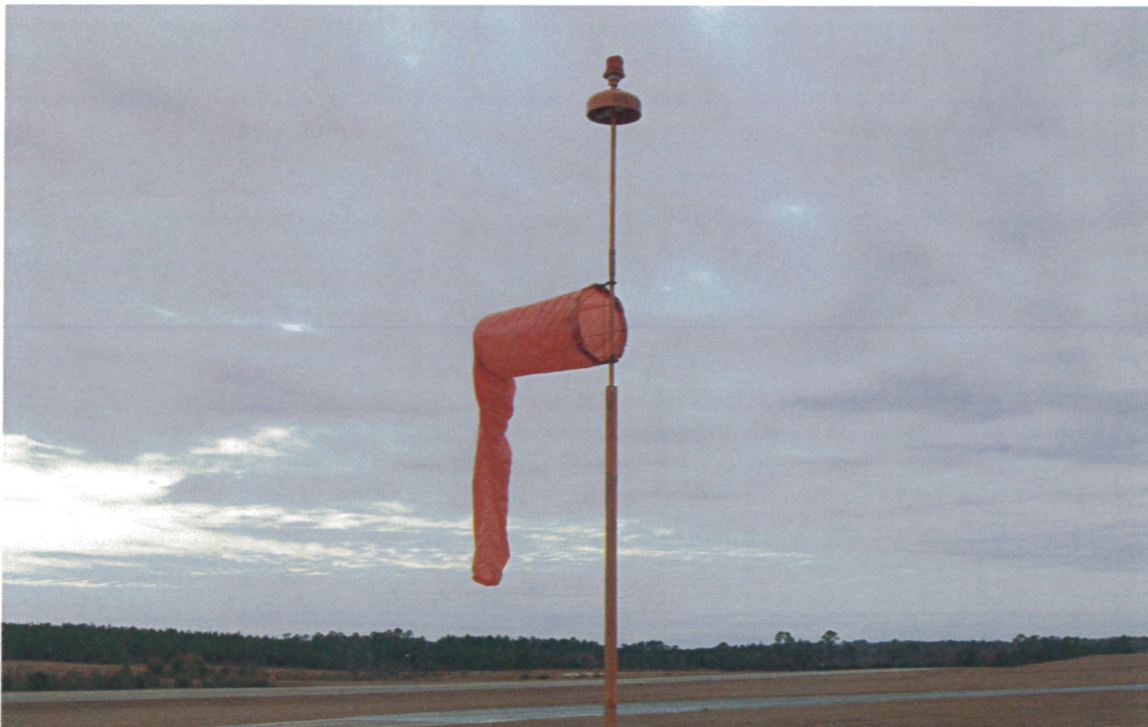
Photo # 4 – Wind Cone

- The wind direction indicator (wind cone) appears operational and in good overall condition (Photo # 4).

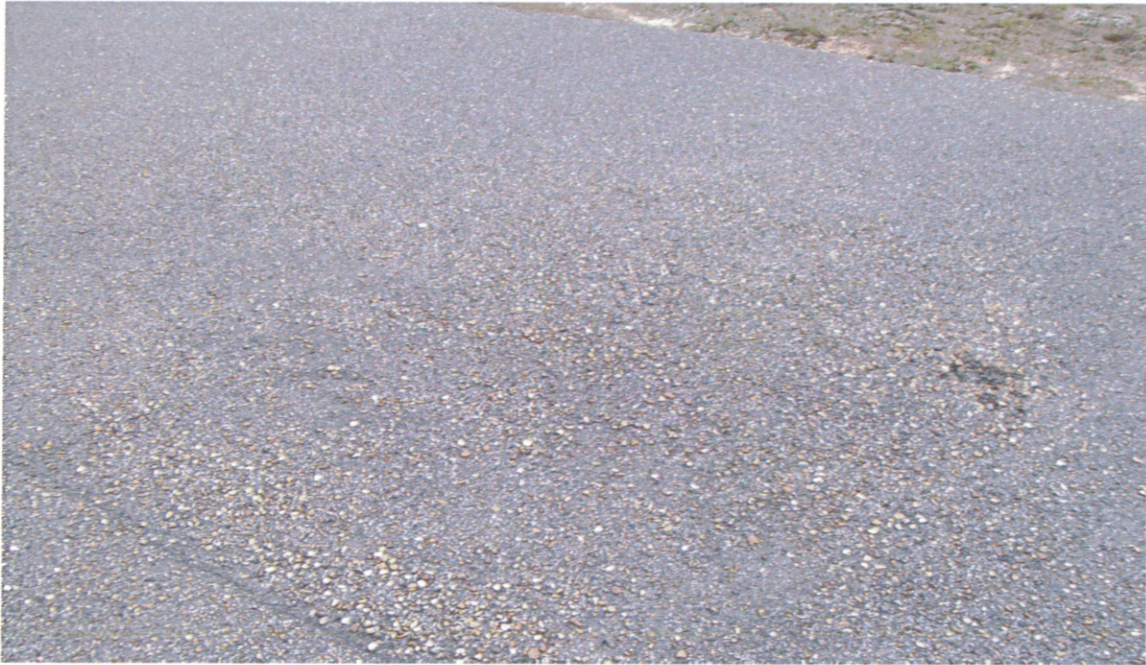
Photo # 5 – Runway Surface

- The airport runway surfaces are beginning to exhibit evidence of slight to moderate raveling with the loss of small and larger aggregate (Photo # 5). The apron has a number of pot holes caused by traffic loading and fatigue (Photo # 6, # 7, and # 8).

- At some point in the future a surface treatment or thin overlay will be needed for the runway; however due to the dangerous debris that may be created by the localized apron potholes, they should immediately be repaired by excavating and rebuilding.
